# **TECHNICAL SERVICE BULLETIN: SV42T SERVO PULLEY**

Original Bulletin: August 2, 2019

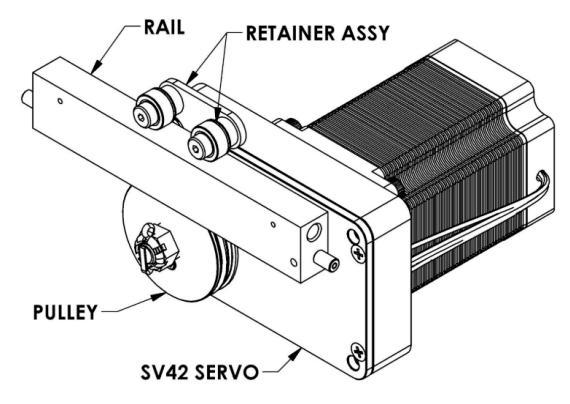
Fig 1: Dynon SV42T servo with linear actuator

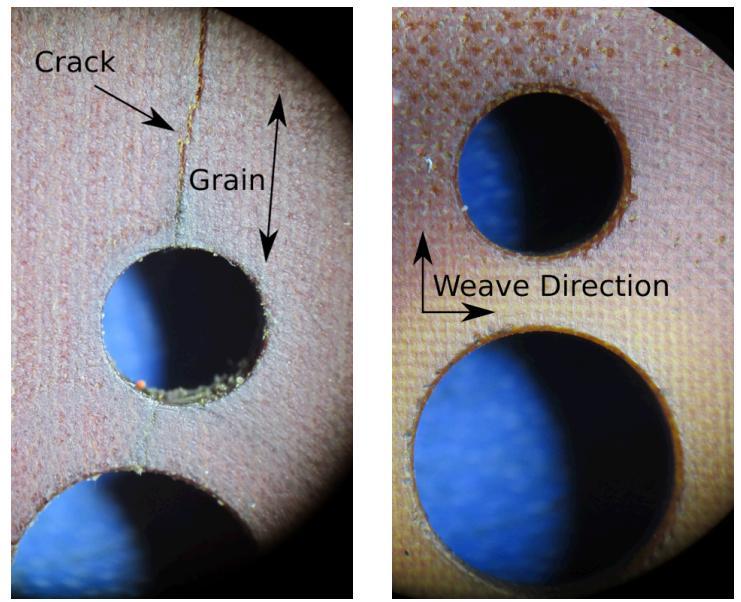
- 1. If you received your SV42T or linear actuator assembly before 12/13/2011, it is unaffected and can remain in service. If you received your servo, or line actuator assembly after this date, inspect it as follows.
- 2. Inspect the pulley for a crack from the center of the pulley through shear screw bore. (Fig 2)

- 4. If no crack is found, inspect the pulley to determine whether it is affected:
  - Unaffected pulleys have a crosshatch weave pattern in their material weave and a plastic-like smooth texture. Inspect the pulley for texture and visually with a magnifier. If a crosshatch weave pattern is present (Fig 3), the pulley may remain in service.

- Affected pulleys have a unidirectional wood-like "grain", and a finish that appears dull looks similar to wood. If your pulley matches this description remove from service and contact Dynon (../contact.php) for repair/replacement. To remove the servo from service, you may opt to remove the e servo assembly, or if more convenient you may remove the entire linear actuator sub-assembly by following the "Servo Arm / Capstan Removal a Replacement Instructions" on the Dynon Documentation Website (../autopilot-components-documentation.php). Whether you remove the servc linear actuator, ensure that any remaining linkages are secured and do not interfere with flight controls. If you choose to remove only the linear actuator, disable the servo circuit electrically to prevent misleading autopilot behavior. This can be accomplished by disconnecting the wiring to the servo and/or removing its fuse or turning off its circuit breaker.

Fig 2: Affected pulley design with crack

Fig 3: Serviceable pulley design

- It may be necessary to engage the autopilot on the ground and apply force to the control surface in order to load the pulley to make the crack vis
- 3. If a crack is found, remove the servo from service and return to Dynon for repair/replacement.
